## Biodiversity Impact Assessment

460.8 MW Vifor Wind Farm Buzău County, Romania

Project No.: 0667256

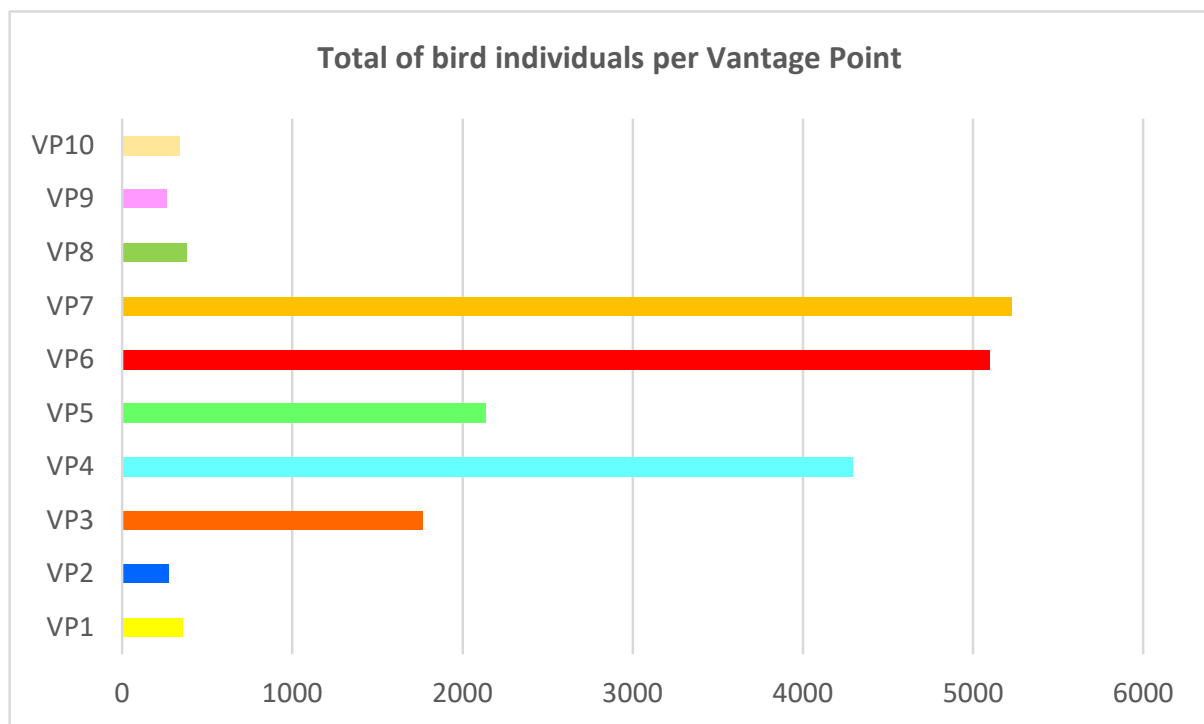
**Figure 4-4 Birds Distribution per Vantage Point**

In terms of abundance, Vantage point 7 recorded the most birds, with 5226 individuals, followed by VP6 with 5097 and VP4 with 4295 (see Figure 4-4).

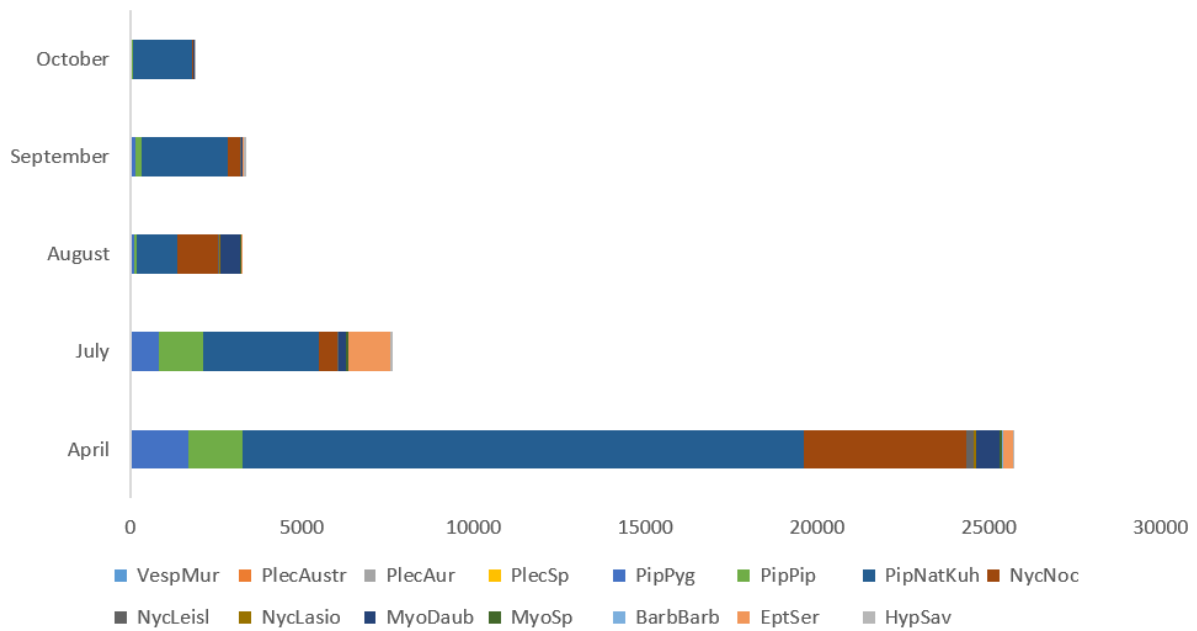
**Figure 4-10 Species`diversity recorded at static detectors from April to October**

Calls of *Pipistrellus nathusii/kuhlii* are dominant on project's area (27,877 contacts) over the three seasons, followed by *Nyctalus noctula* (6,913 contacts) and, *Pipistrellus pipistrellus* (3,309 contacts). In addition, of the least frequently recorded species, there were only 34 contacts for *Barbastella barbastellus*, which is listed on Annex II, IV of habitats Directive and Near Threatened (EU)/Vulnerable (globally) on IUCN Red list – see figures below.

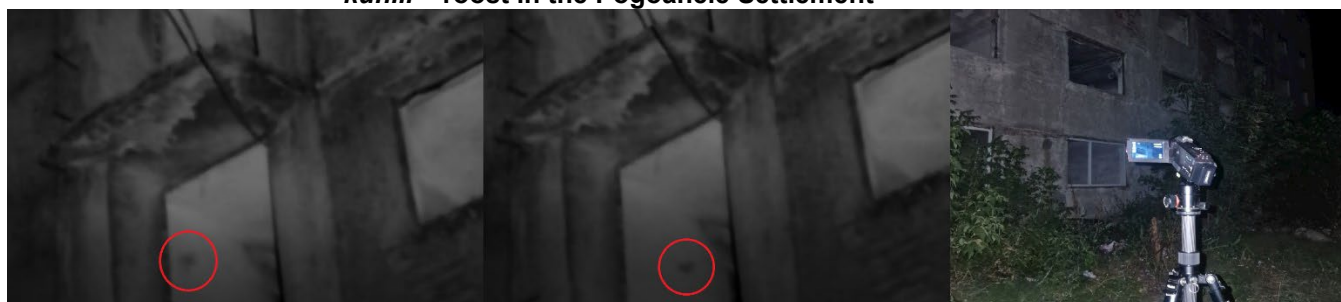
**Figure 4-16 Infrared camera monitoring – example of flight path of re-entry for *Pipistrellus kuhlii* – roost in the Pogoanele Settlement**

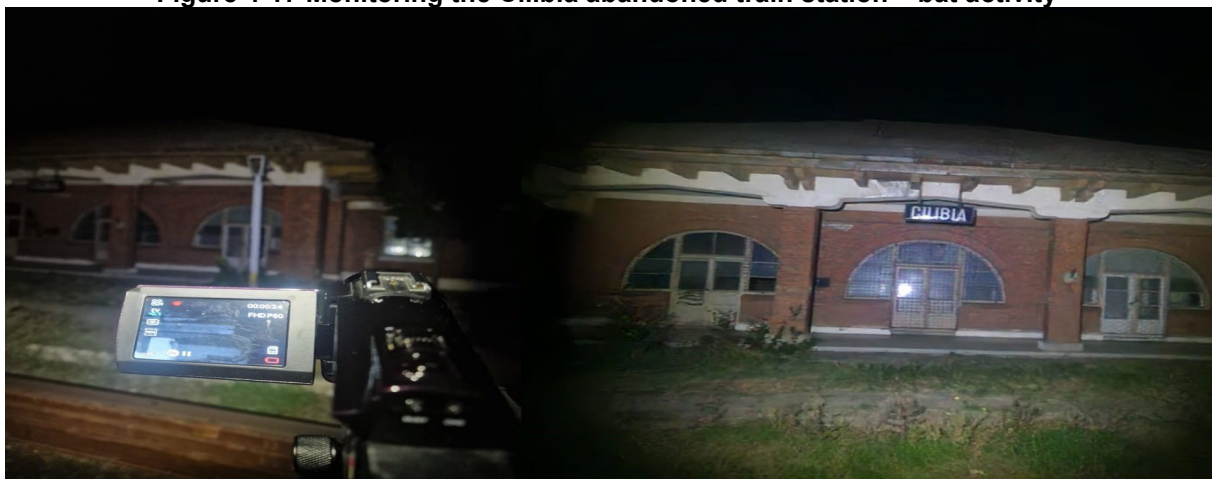
**Figure 4-17 Monitoring the Cilibia abandoned train station – bat activity**

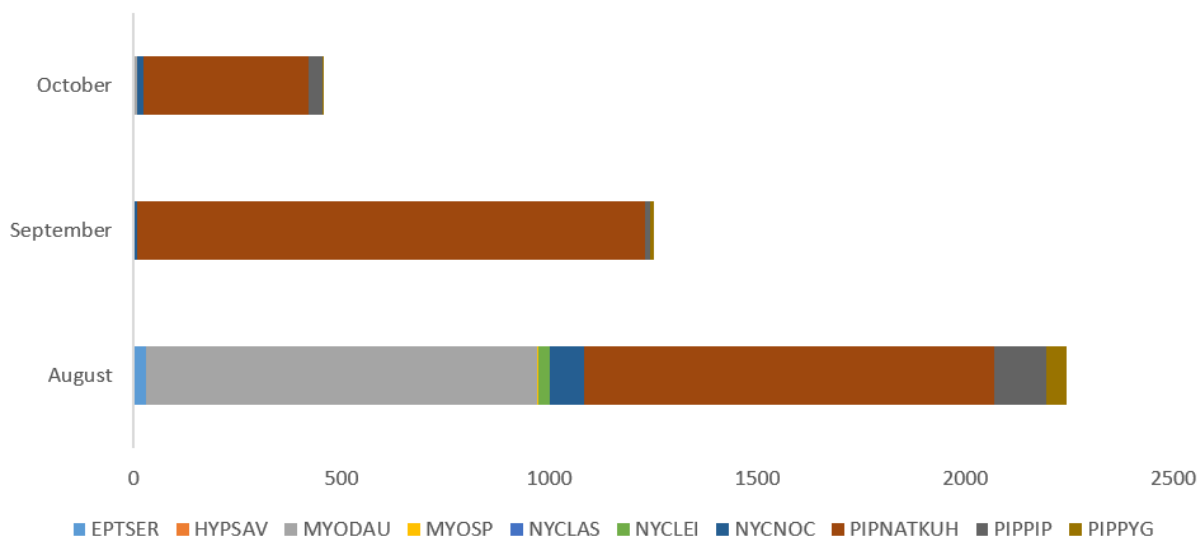
**Figure 4-19 Bats recoded on static detector at ST5 – full night observations August - October**

The first night of full observation was in August (12-13.08.2022). The static detector identified 2242 recordings of 9 species. Calls of *Pipistrellus nathusii/kuhlpii* were dominant (984 recordings), followed by *Myotis daubentonii* (942 recordings). Among the visual (human) observations, a minimum of nine *Nyctalus noctula* were observed feeding around ST5 with smaller numbers transiting high over the site. The noctules were followed by at least 12 individuals of *Pipistrellus kuhlpii* hunting in large circles and along the channel, just above the monitoring point. *Myotis daubentonii* was almost constantly observed in much lower numbers compared to the other bat species recorded. Two individuals were observed flying above the hygrophilous vegetation of the channels, periodically dropping towards the water level to feed.

The results from the combined static and human observer surveys at ST5 indicate the following;

- Although there was no contemporaneous observations during April the number of passes and diversity of species then was significantly different from subsequent months which likely supports the bat experts view that it coincided with northward bat migration.

- A relatively small number of bats appear to be driving the activity recorded on the static detector, particularly when they are feeding in the vicinity of the static detector. Feeding was the dominant behaviour observed.
